Rehabilitation of Distressed Airport Pavements

Using The GlasGrid® Pavement Reinforcement System to Mitigate Reflective Cracking

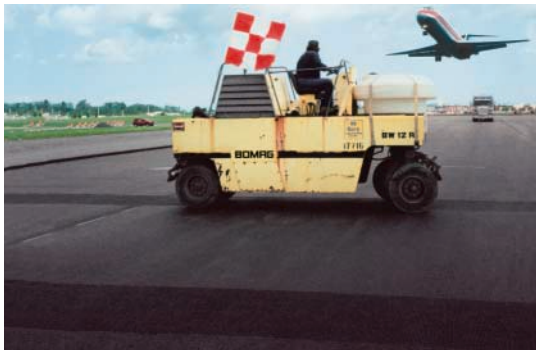
The GlasGrid® System becomes the hidden strength in airport pavement structures.

The GlasGrid® Pavement Reinforcement System provides additional support to resist the migration of reflective cracks in airport pavement structures. When GlasGrid mesh is “sandwiched” between a leveling course and the surface course asphalt, it becomes the hidden strength in the airport pavement – designed to redirect vertically migrating cracks horizontally, thereby effectively dissipating them.

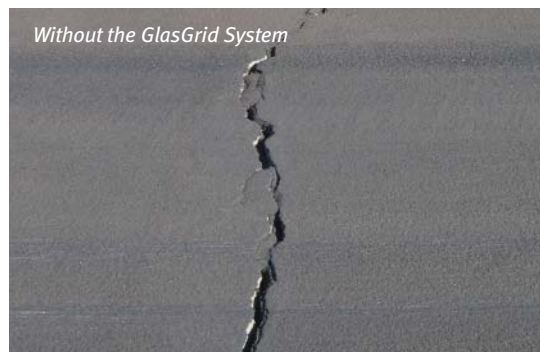
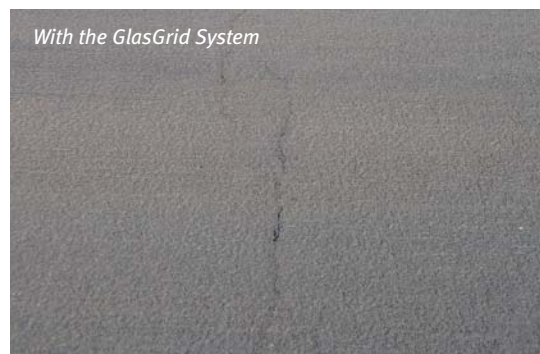
Pavement surface condition following 11 years of post-rehabilitation service.

A site visit on January 31, 2007, showed that following 11 years of service, the runway where the GlasGrid System was installed has resulted in only minor cracking. In contrast, an area that was left unreinforced for comparison purposes demonstrated significantly more severe cracking up to 1 in. wide.
